Comprehensive Traffic Signals System Evaluation

Prepared for: The City of Corner Brook

Prepared by: Harbourside Transportation Consultants

October 10, 2018

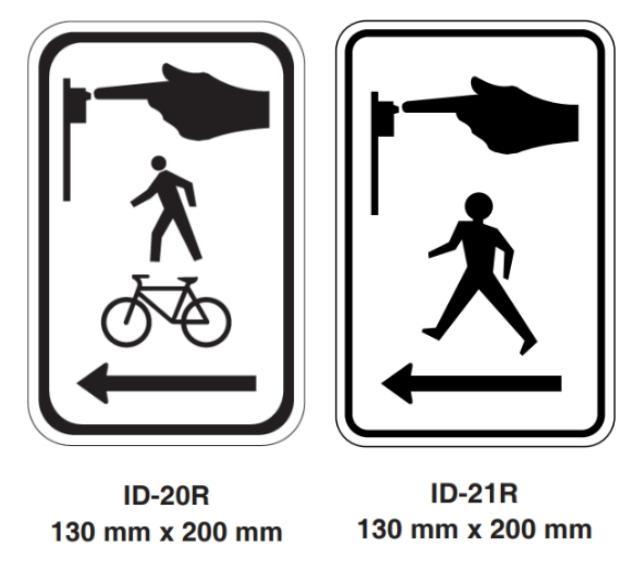
Pedestrian pushbutton signage is only provided at five of the 14 signalized locations where pedestrian pushbuttons are present. Signage is missing for one or more pushbutton and/or in poor condition at four of these locations. In addition, different types of signs are used at each location, the pushbutton signage provided should be consistent across all intersections.

Figure 2: Signalized Intersection Crossing Sing (ID-20) and Pedestrian Pushbutton sign (ID-21)

The existing signage associated with the pedestrian pushbuttons should be replaced and new signage installed at all other signalized locations so that a sign is provided with each pushbutton. Where two pushbuttons are used on each pole to control the two crosswalks separately, the appropriate left or right version of MUTCD's ID-21 sign or ID-20 sign, shown in Figure 2, should be used for each button so that the arrow points in the direction of the crosswalk the button controls.

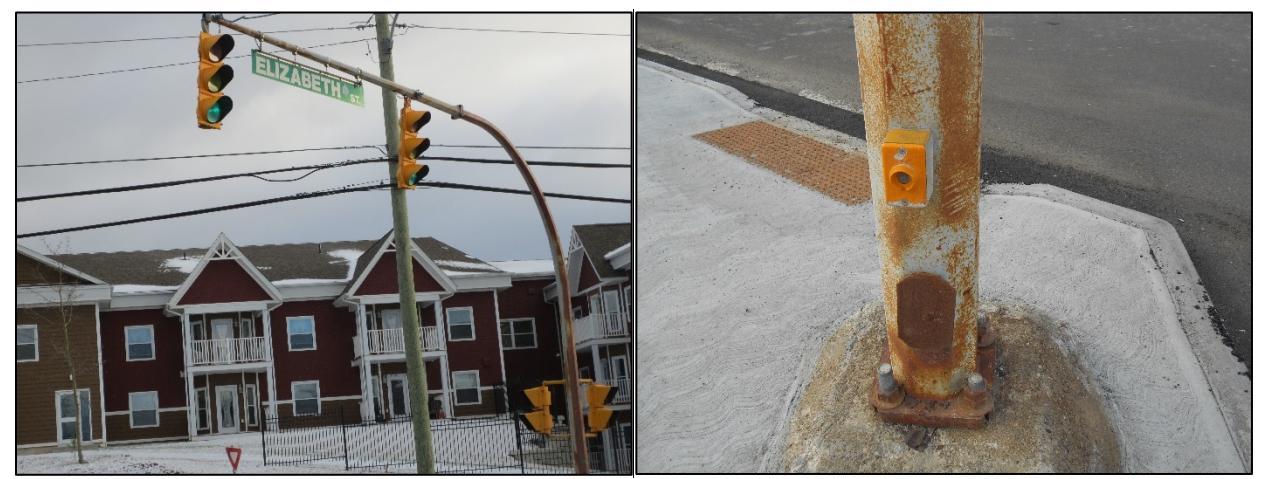
Figure 3: Examples of corrosion at O'Connell Drive & Elizabeth Street, classified as poor condition

Upon consultation with Harbourside Engineering Consultants, it was determined that any "Pole System" exhibiting signs of corrosion or excessive wear should be replaced. It is recommended that the poles at all seven locations described above be replaced, priority should be given to replacing the poles in very poor condition first.

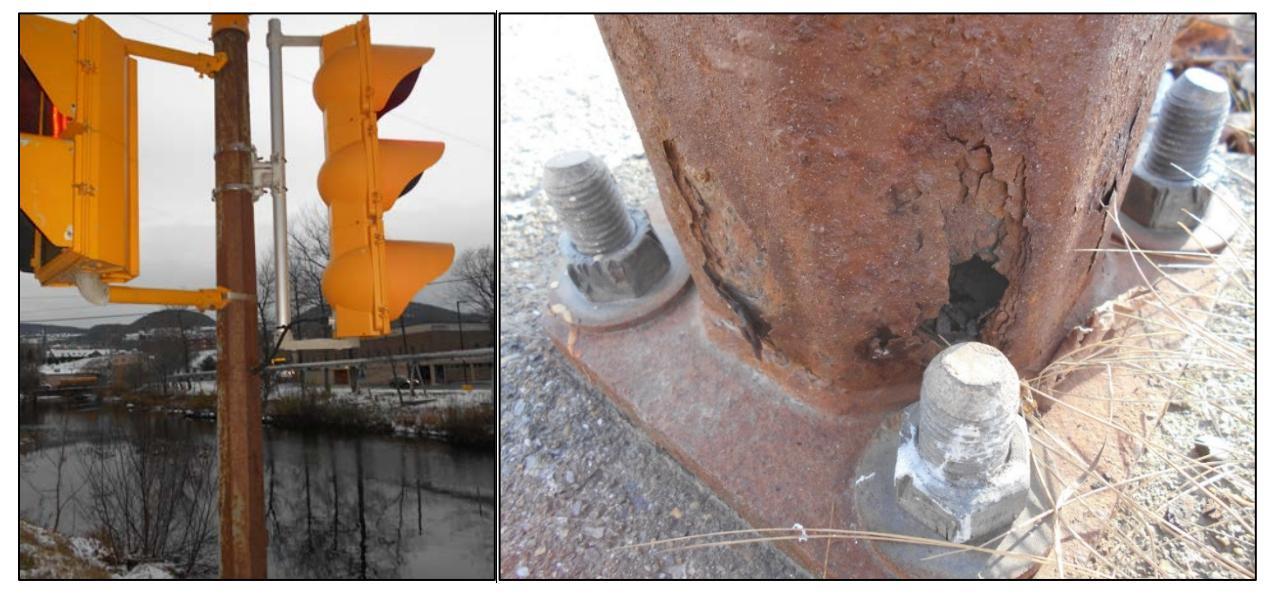
Figure 4: Examples of corrosion at Lewin Parkway & Mill Road, classified as very poor condition
